624.350971447
Q315
1918

BIBLIOTHEQUE
SAINT-SULPICE MONTREAL

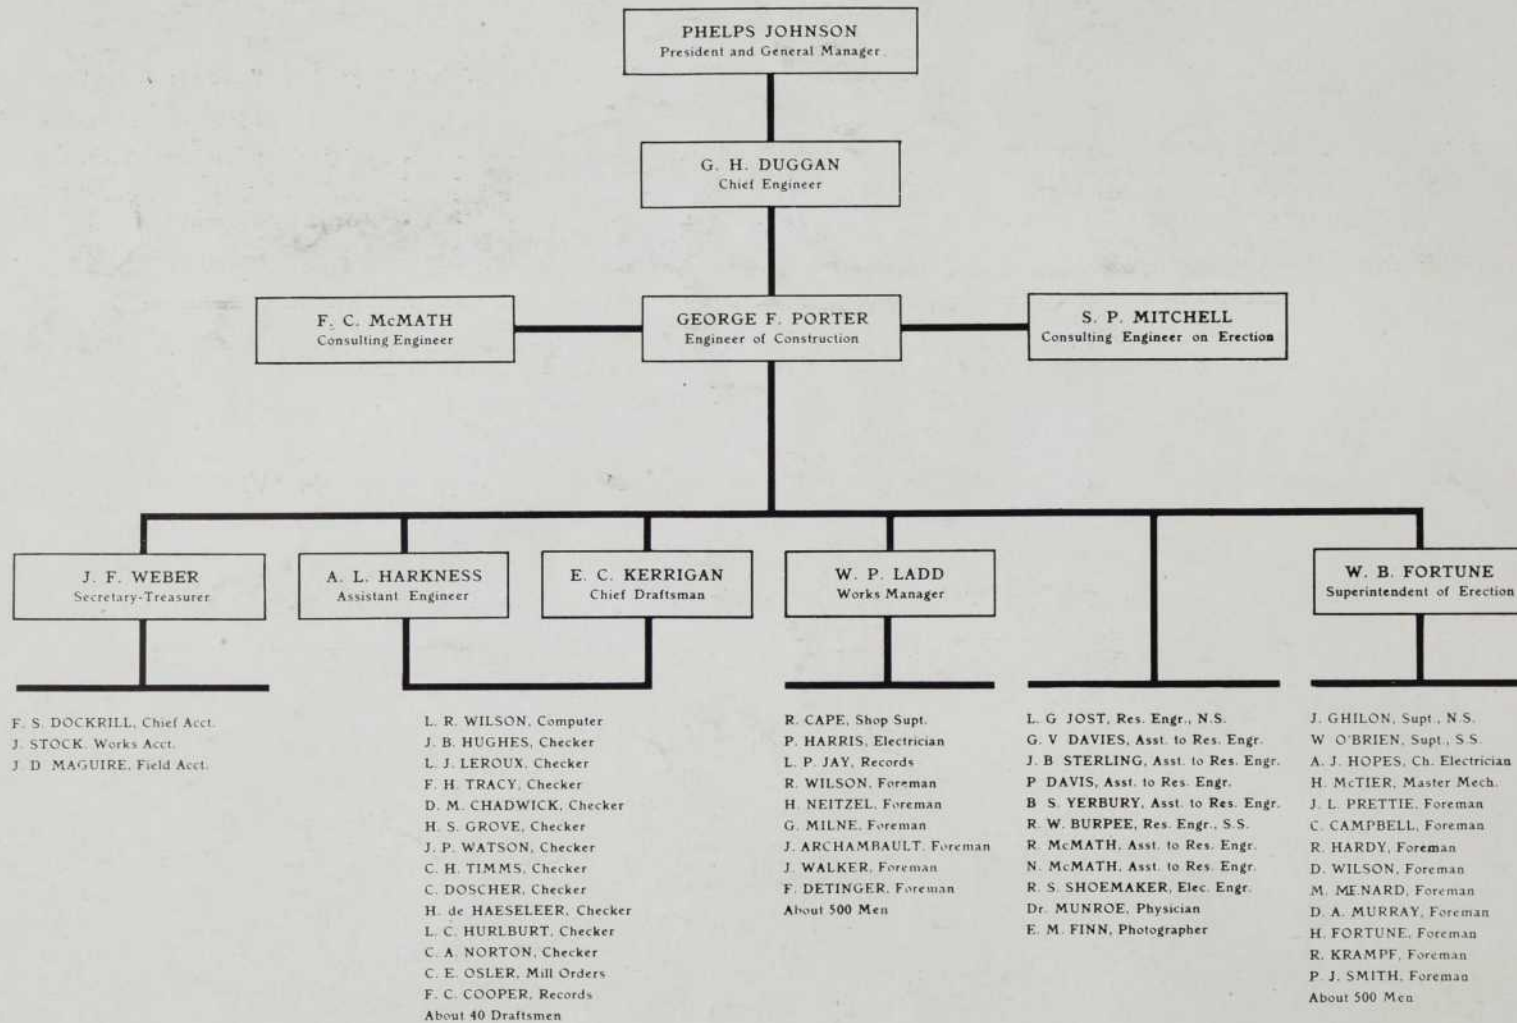
ORGANIZATION OF ST. LAWRENCE BRIDGE CO., LIMITED

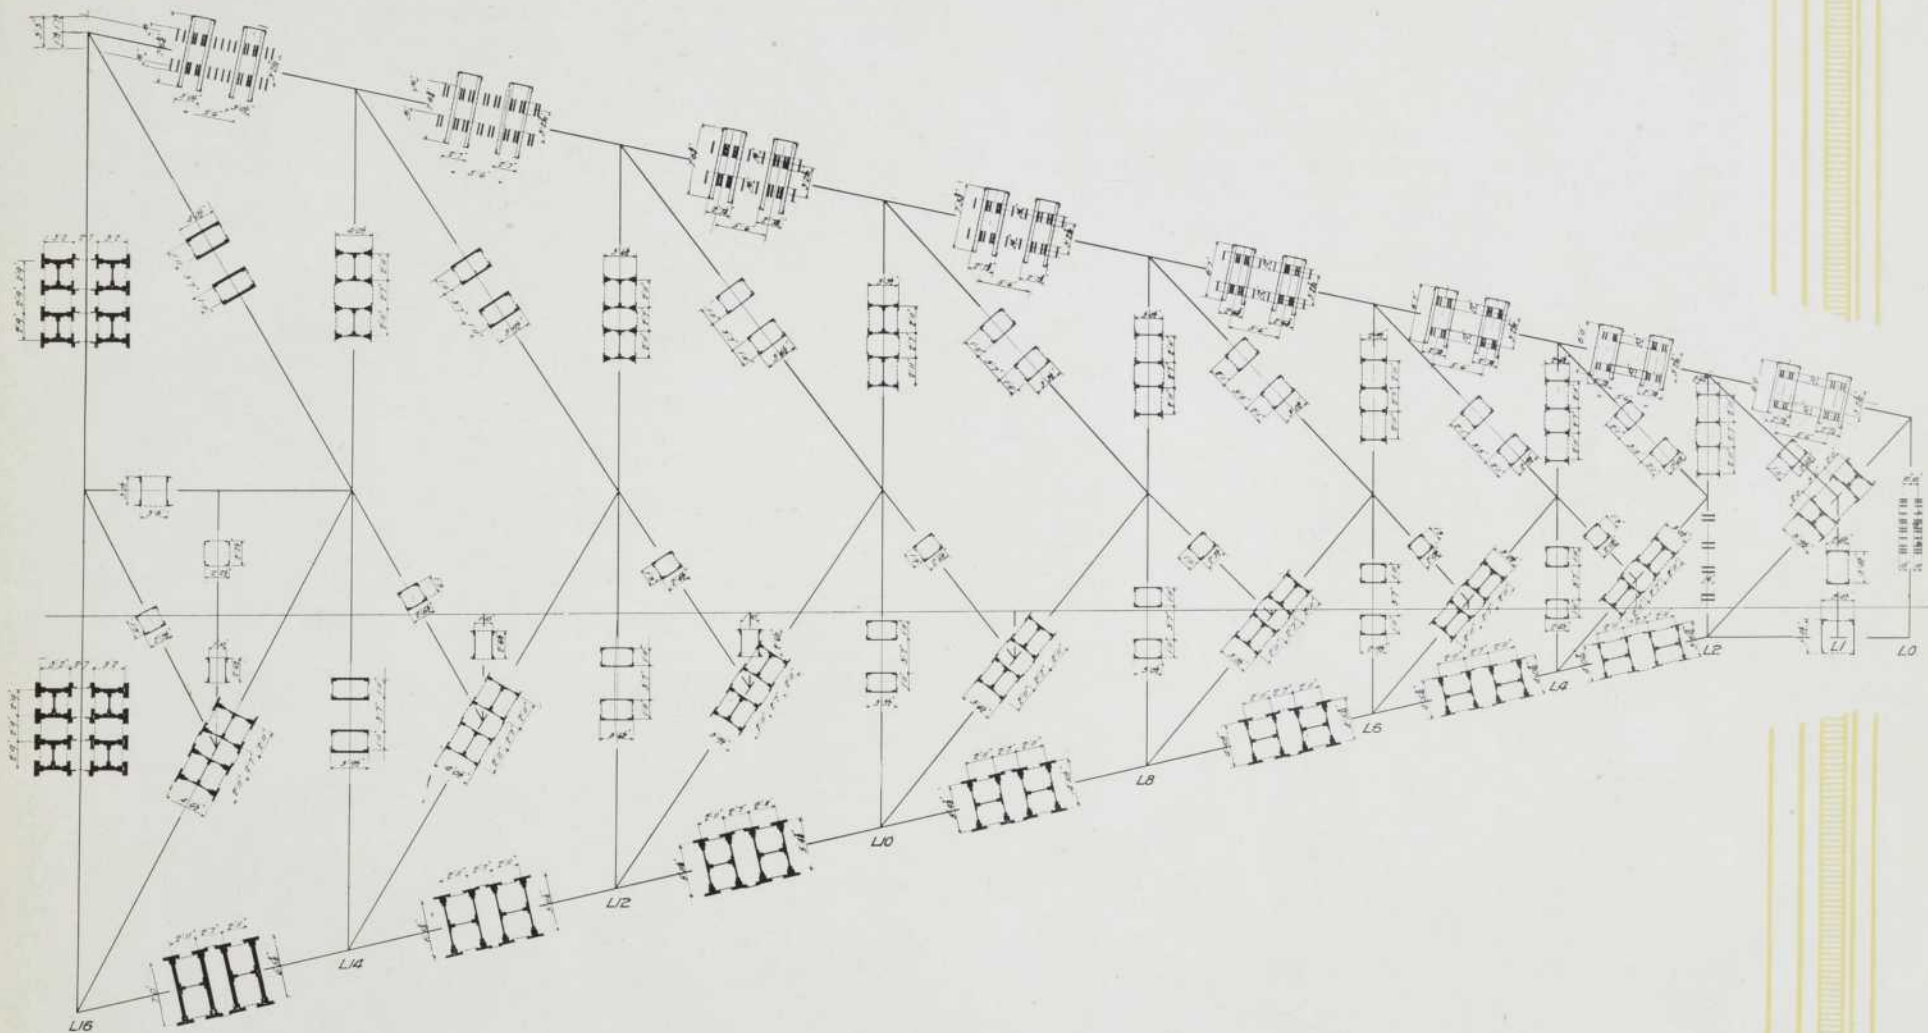
3—Cross sections of important members of the cantilever arms
 NOTE: The cross sections of the members of the anchor arms are similar

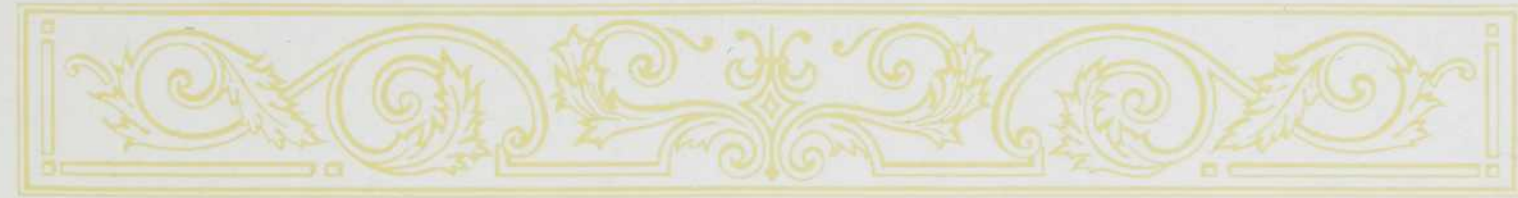
PLATE 4 shows, to the same scale, the elevation of the Quebec Bridge and all the great cantilever bridges heretofore constructed. It will be seen that the Quebec Bridge with its span of 1,800 feet exceeds the span of the Forth Bridge by 100 feet, and that these two are in a class by themselves—the next longest, the Blackwell's Island Bridge, being less than two-thirds the span of the Quebec Bridge.

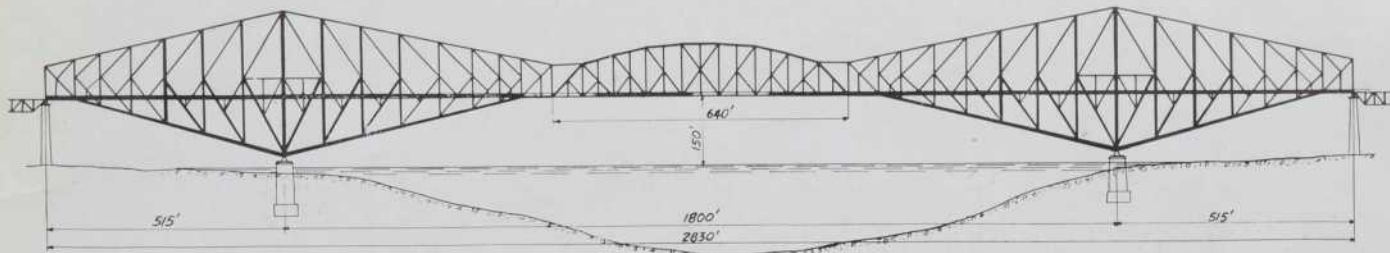
The masonry was satisfactorily completed and work on the superstructure proceeded until the South anchor arm, cantilever arm and nearly half of the suspended span were erected when on the 29th August, 1907, all of this portion of the superstructure suddenly collapsed.

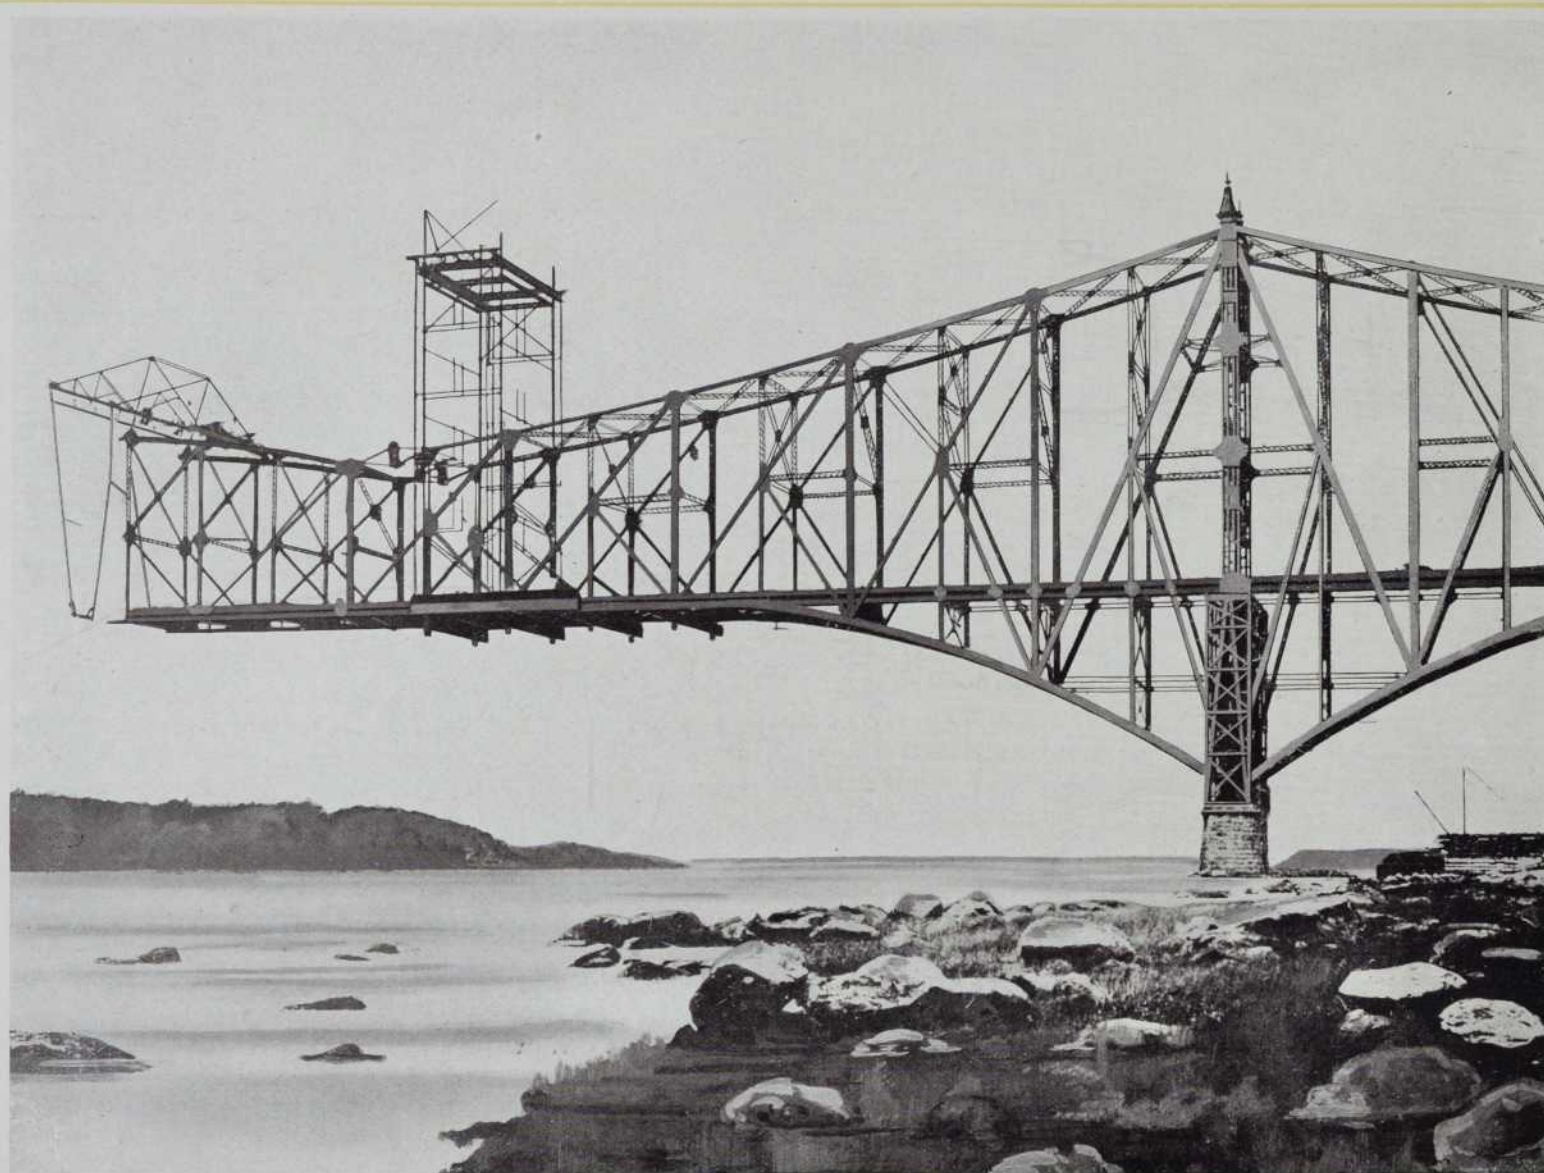
5—Photograph of the Phoenix Company's bridge taken August 28, 1907, showing condition of the structure just previous to its failure

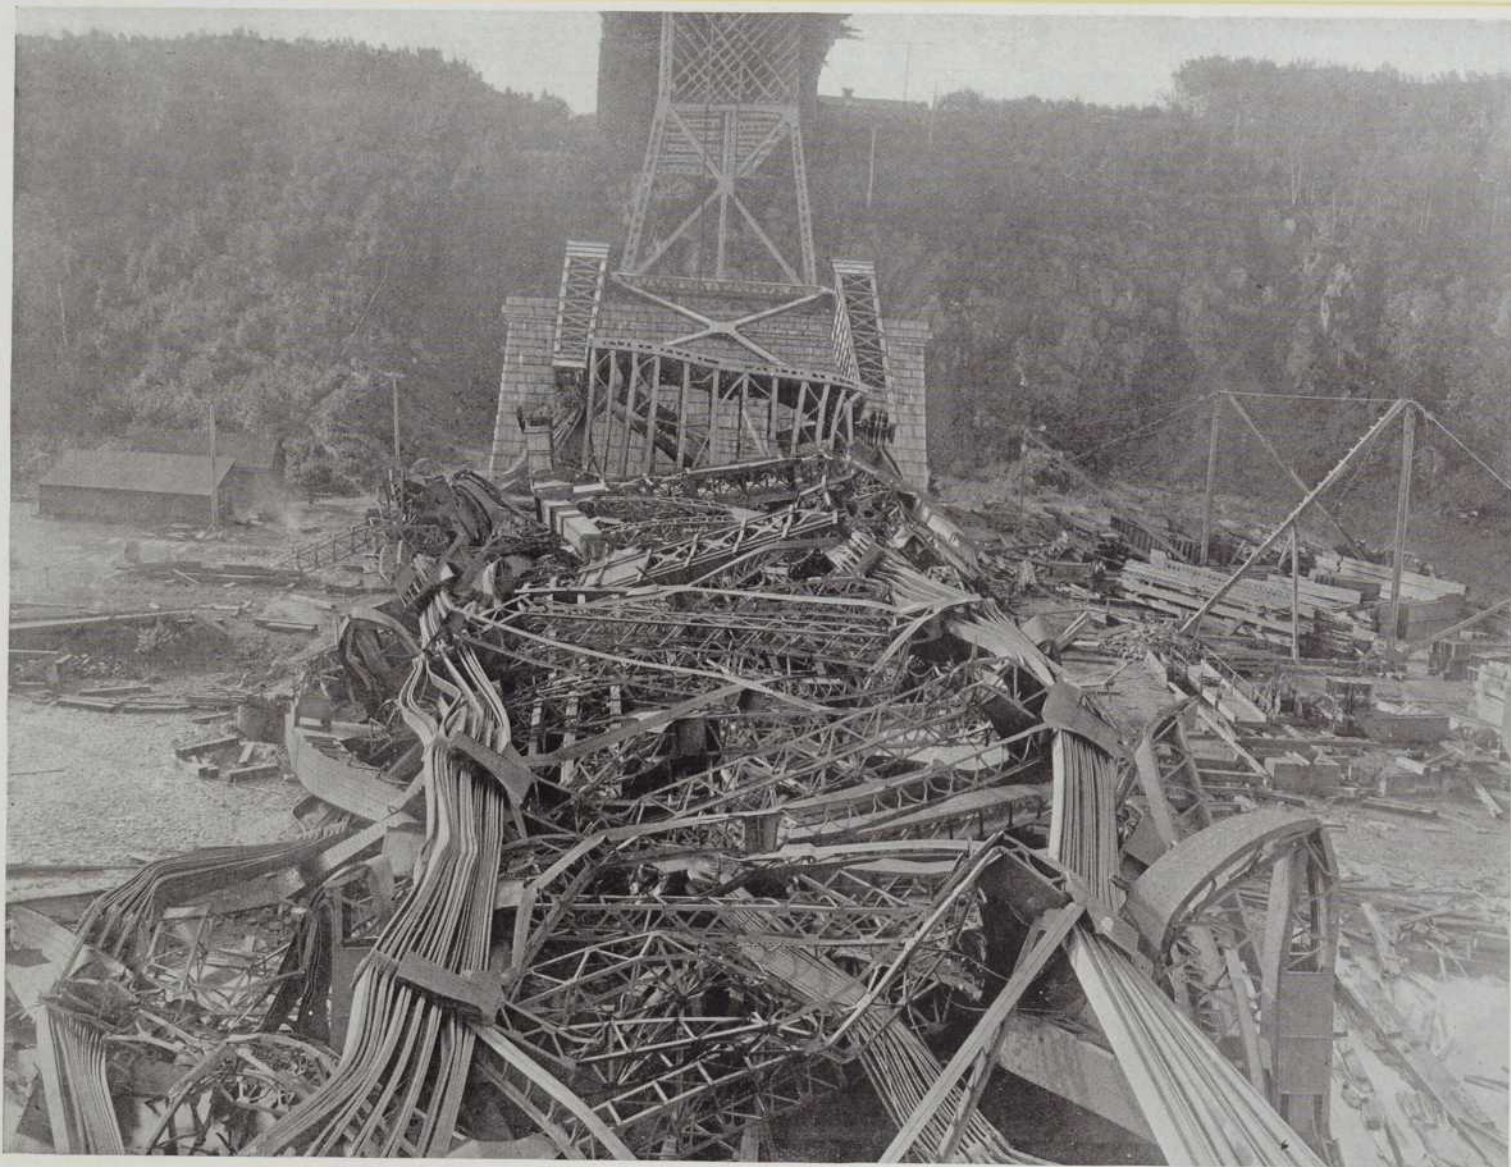
6—General view after the collapse from the Main pier Southwards

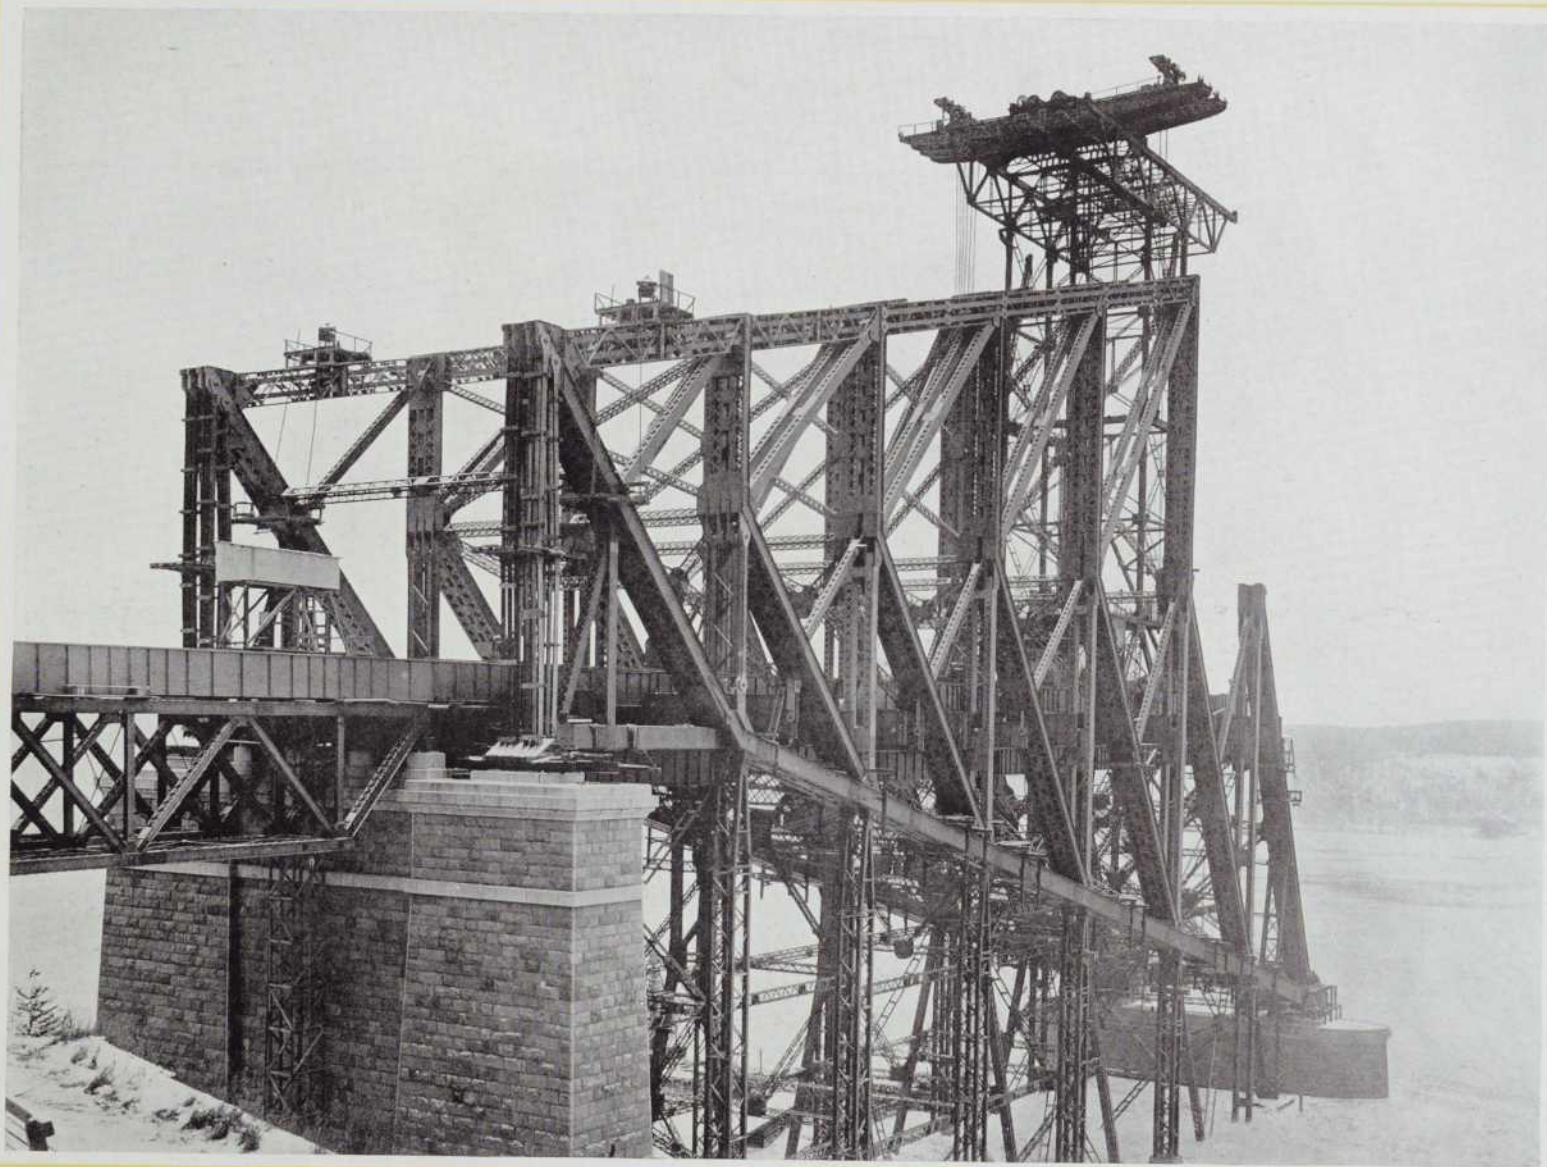
26—Condition of the North anchor arm at the close of the season of 1914

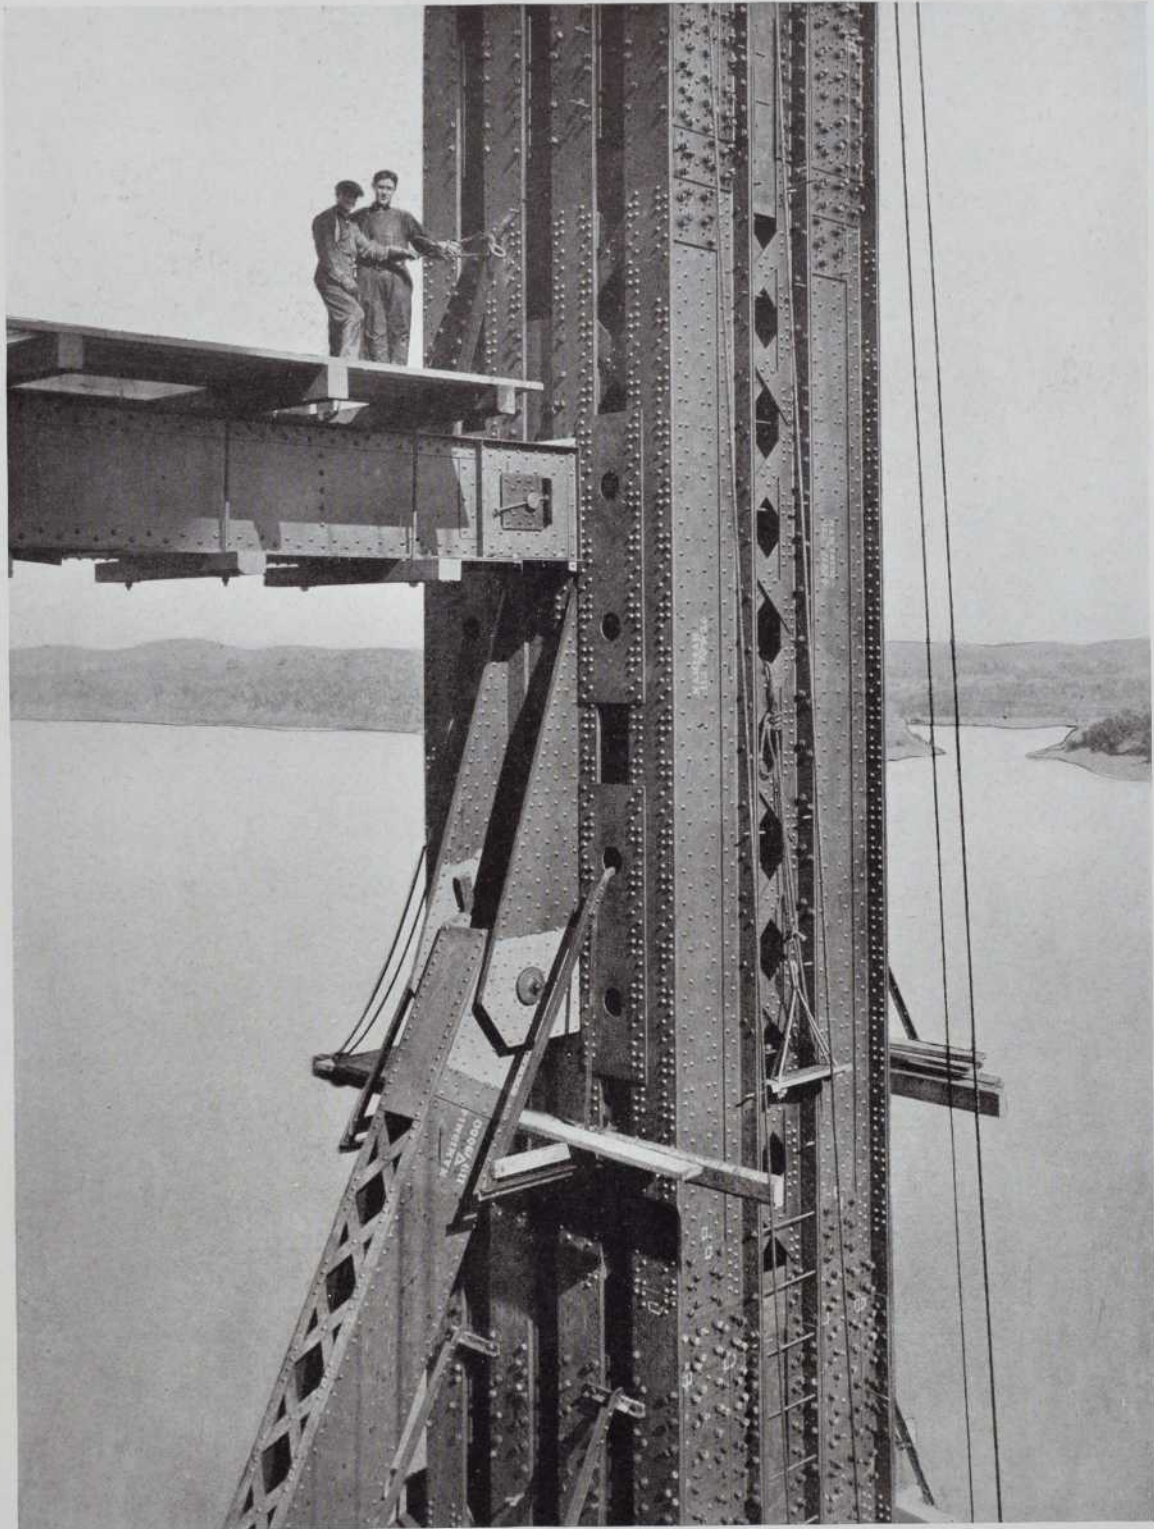
27—Connection of web members at the centre of the large post over the main pier

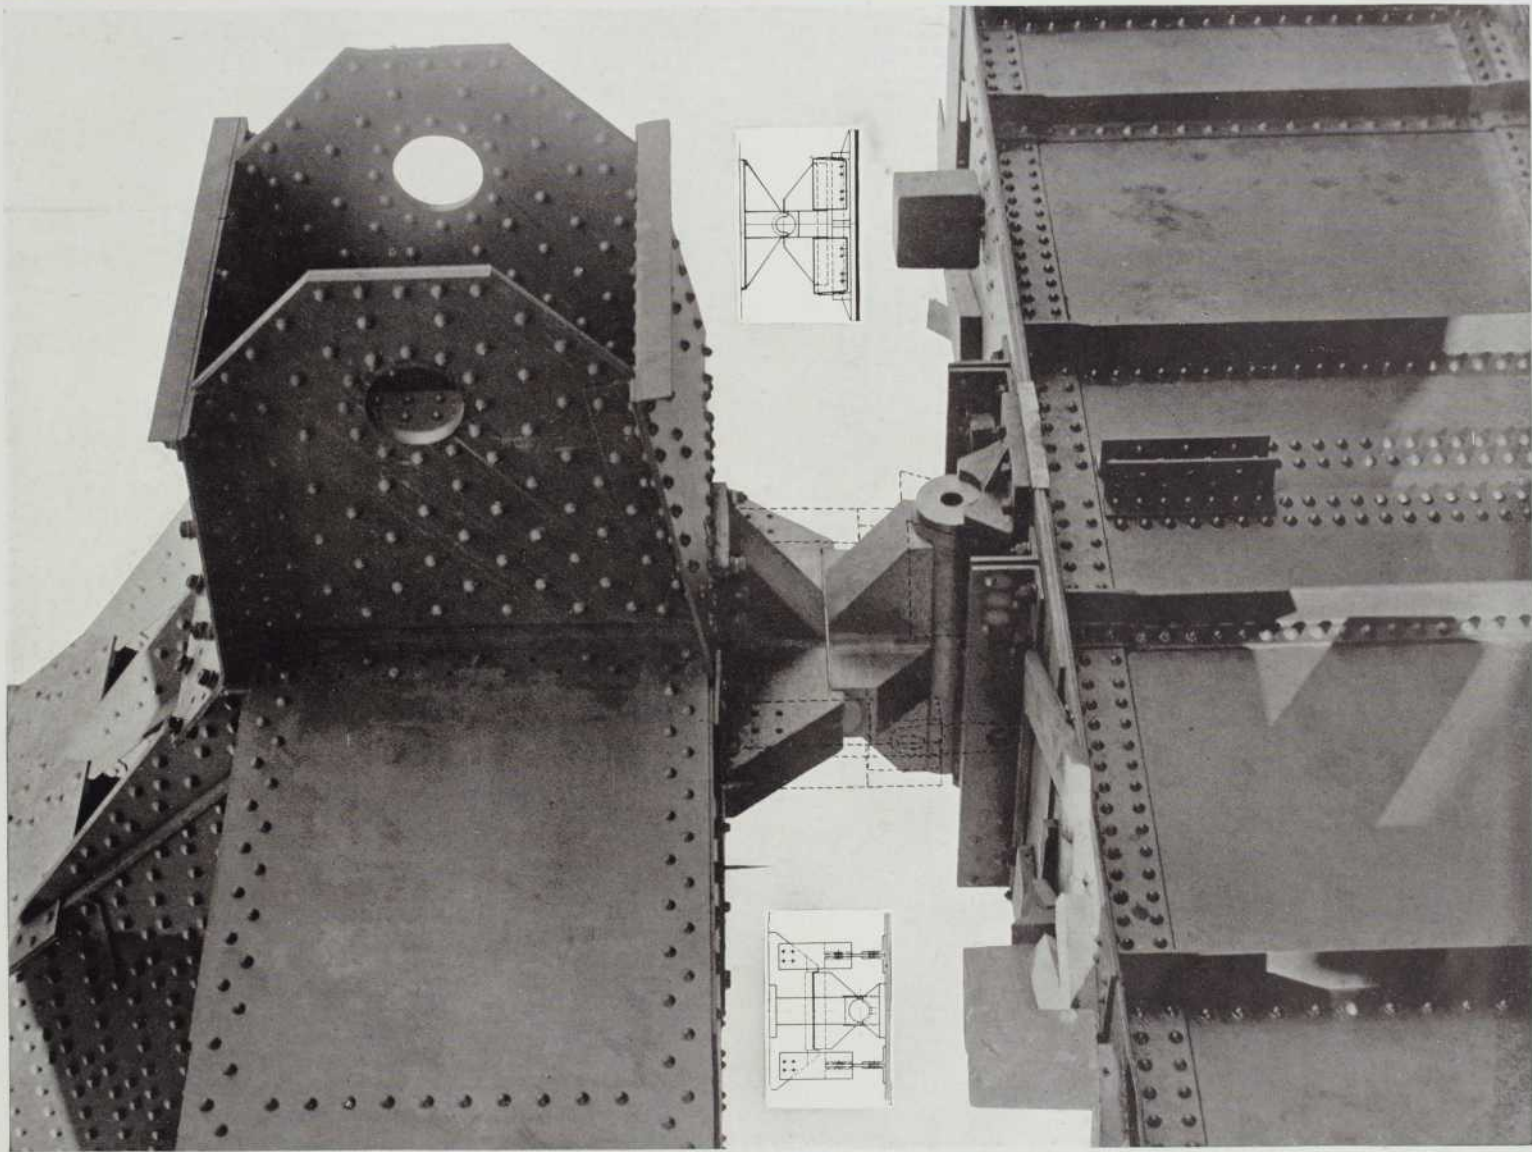
64—Details of the shoe, which failed when supporting the suspended span during erection

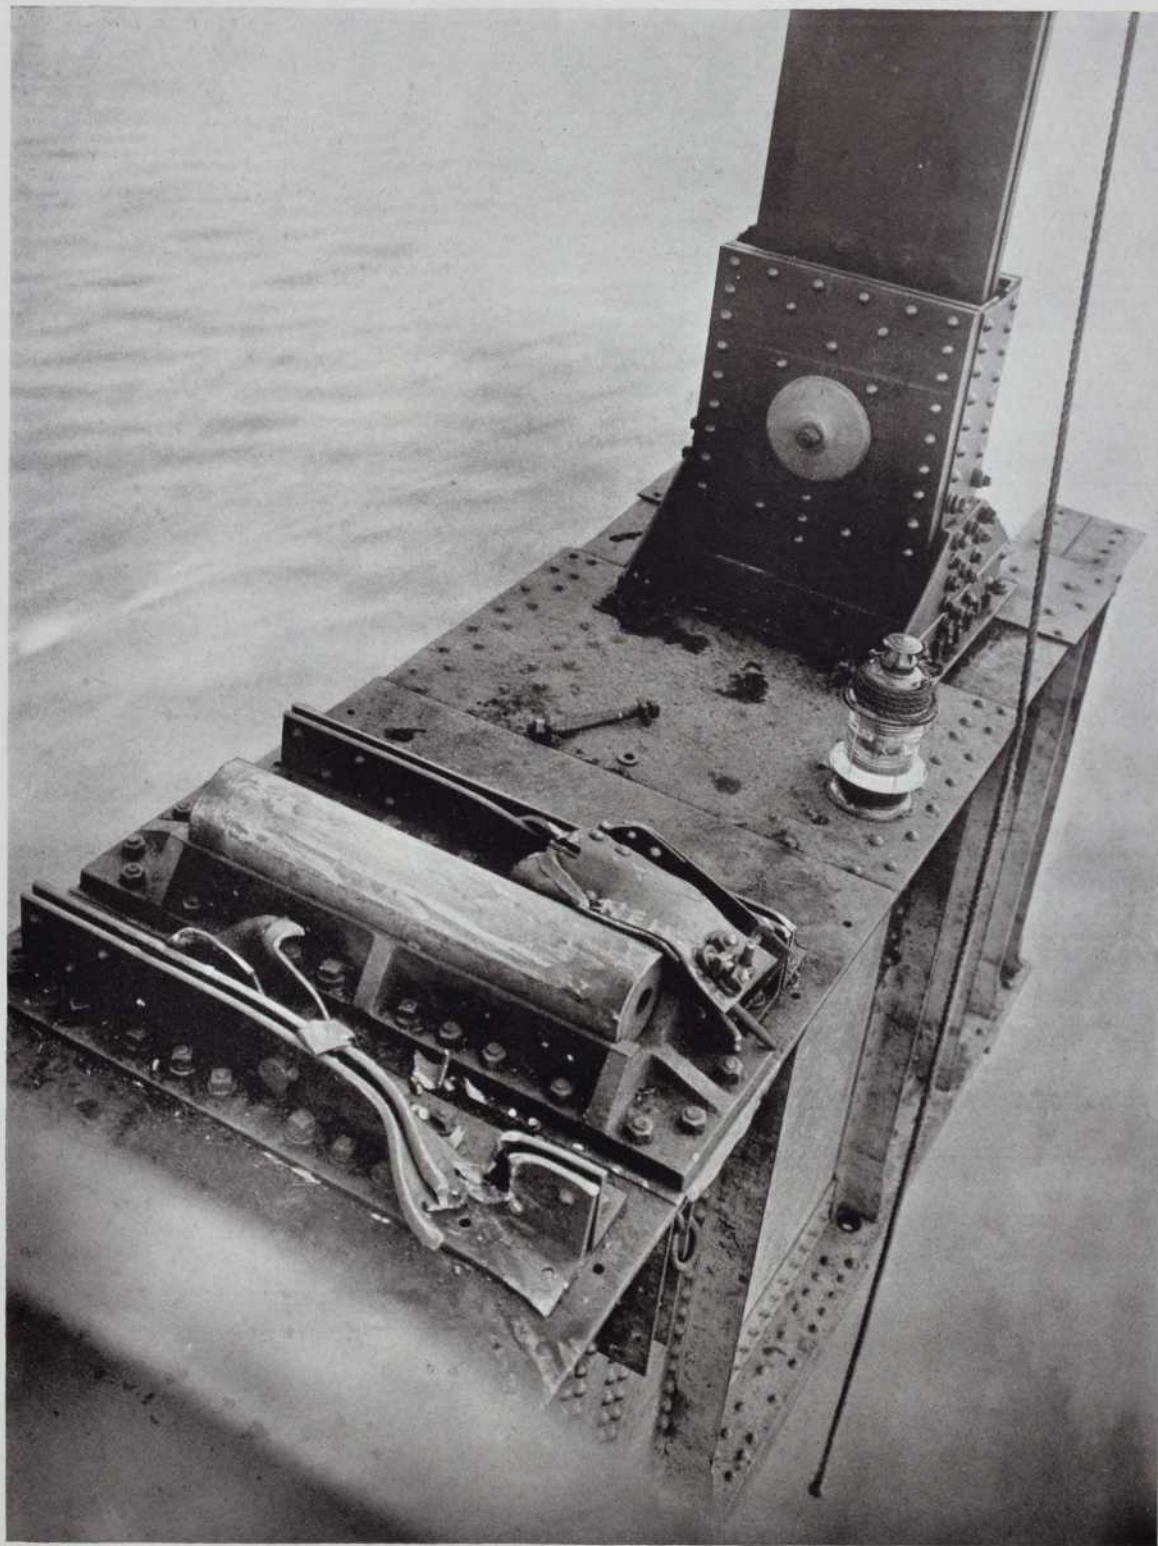
65—Condition of lower shoe and carrying girder after the loss of the suspended span

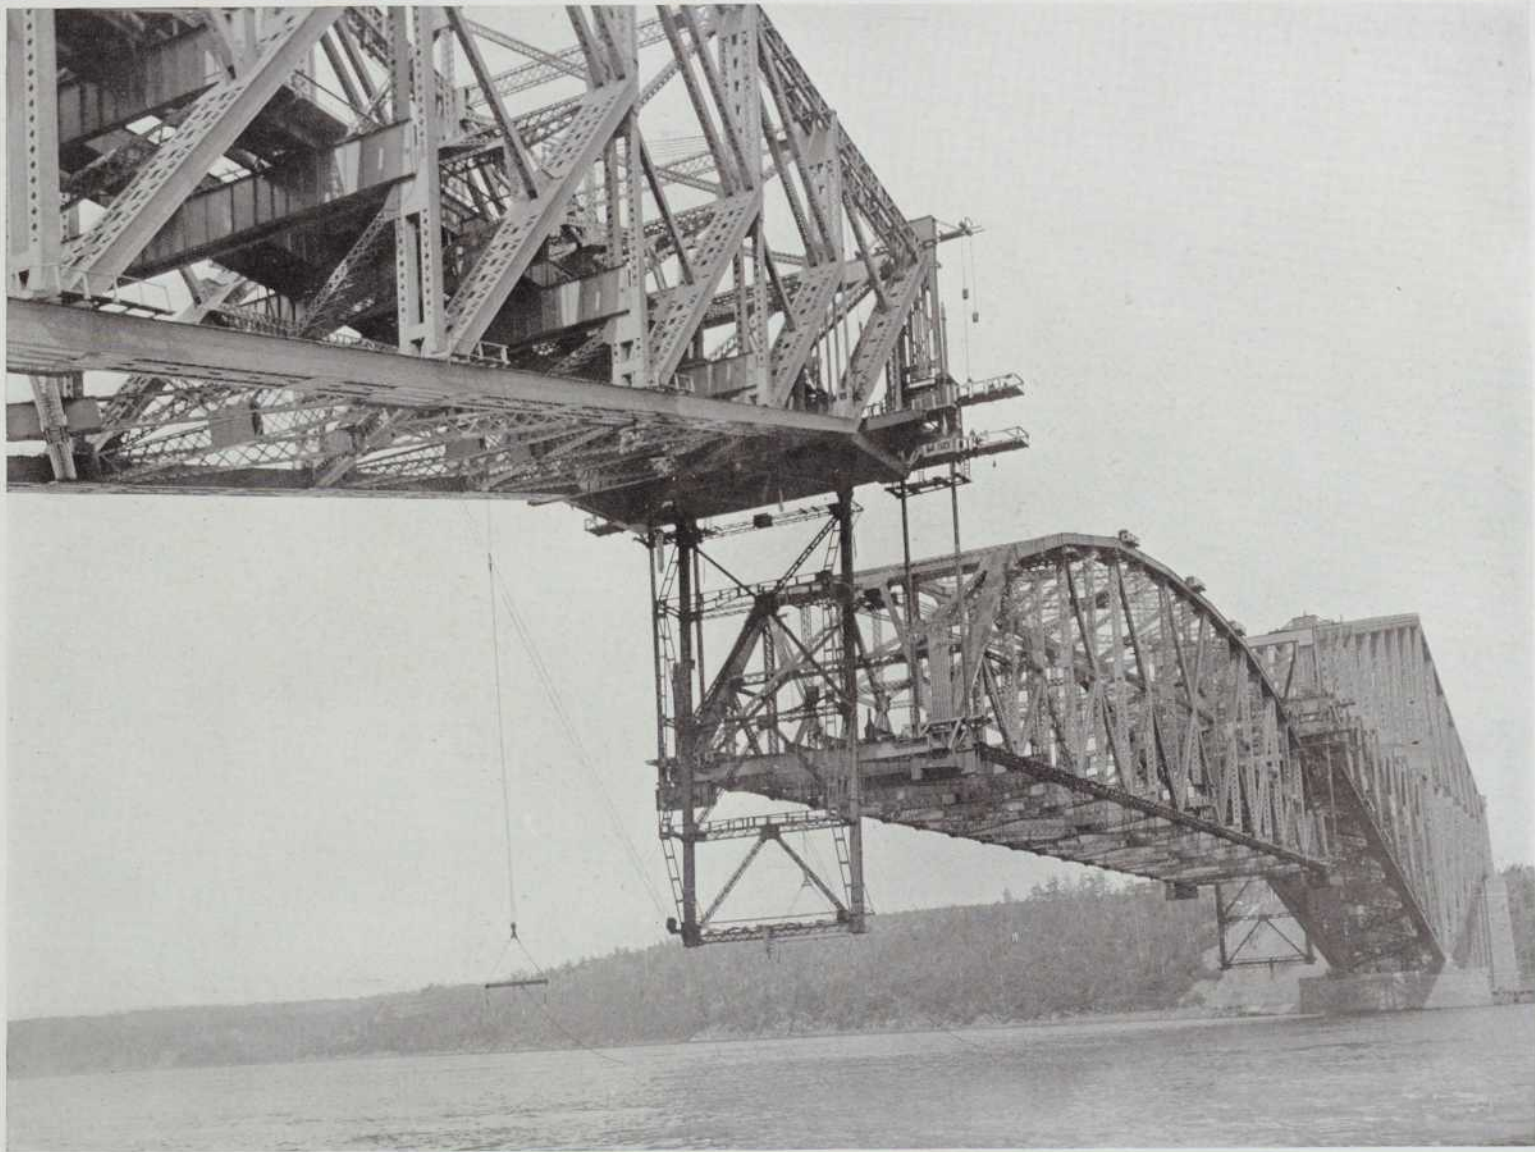
66—The suspended span about half way up, September 18th, 1917
